# Form 1—Vendor's statement

(Section 7 *Land and Business (Sale and Conveyancing) Act 1994*)

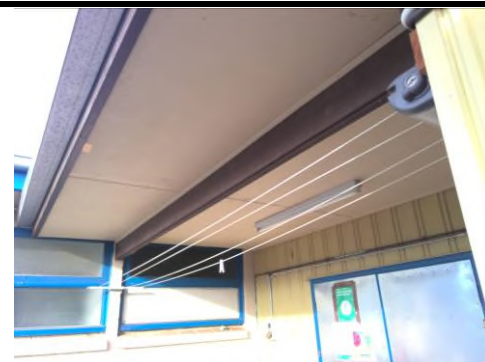
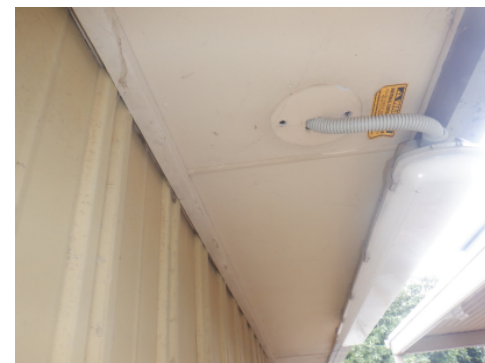
| LOCATION - DESCRIPTION | EXTENT | ASBESTOS ASSESSMENT | CONDITION | SAMPLE NO VISUAL TEST | SIGNAGE STATUS |
| B. External. South west corner of building wall mounted electrical backing board – Black resin board. | Approx 0.15m <sup>2</sup><br>Accessible | Chrysotile asbestos (typical) | Moderate<br>Unsealed<br>Non friable | 03/TH/010519 | Visible |

| LOCATION - DESCRIPTION | EXTENT | ASBESTOS ASSESSMENT | CONDITION | SAMPLE NO VISUAL TEST | SIGNAGE STATUS |
|---|---|---|---|---|---|
| <p><b>Low Risk P4</b> – Avoid physical and mechanical damage. When maintenance/upgrade is required, recommend removal and reinstate with non-asbestos product.</p> | | | | | |

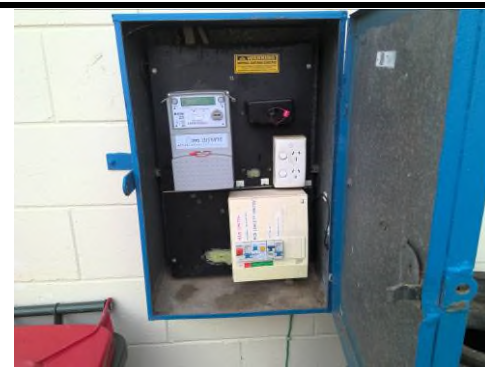
| LOCATION - DESCRIPTION | EXTENT | ASBESTOS ASSESSMENT | CONDITION | SAMPLE NO VISUAL TEST | SIGNAGE STATUS |
| C. External, south west corner of building electrical cabinet – dust / debris. | - | - | - | 04/TH/010519 | - |

| LOCATION - DESCRIPTION | EXTENT | ASBESTOS ASSESSMENT | CONDITION | SAMPLE NO VISUAL TEST | SIGNAGE STATUS |
|---|---|---|---|---|---|
| Cabinet cleaned by Carters using Class H Vacuum on the 24/06/2019 refer to certificate of completion attached to Appendix D | | | | | |

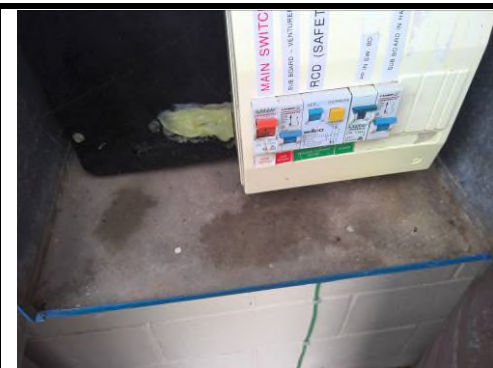
| LOCATION - DESCRIPTION | EXTENT | ASBESTOS ASSESSMENT | CONDITION | SAMPLE NO VISUAL TEST | SIGNAGE STATUS |
|---|---|---|---|---|---|
| <b>SURVEY FINDINGS and HAZARD MANAGEMENT RECOMMENDATIONS</b> | | | | | |
